# RECALL CAMPAIGN BULLETIN

NTB09-107

## VOLUNTARY SAFETY RECALL CAMPAIGN ROGUE, MURANO, cube<sup>®</sup>; WHEEL VALVE STEM NUT

**CAMPAIGN ID #:** R0908  
**NHTSA #:** 09V-393  
**APPLIED VEHICLES:** 2008 – 2009 Rogue (S35)  
2009 Murano (Z51)  
2009 cube<sup>®</sup> (Z12)

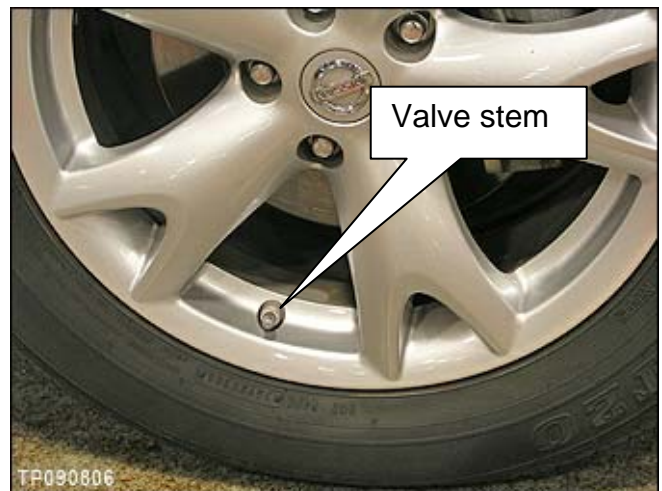
Figure 1

1. Position the valve stem to the lower area (between 4 and 8 o'clock position).
2. Clean dirt and debris from around the valve stem.

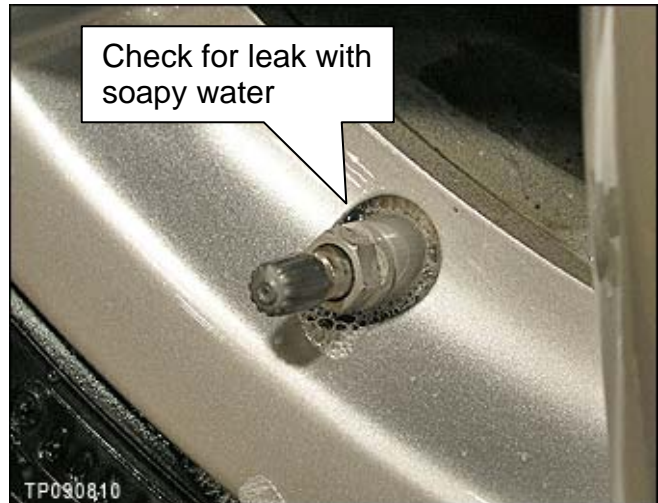
Figure 3

6. Check for leak around the valve stem.

- Apply soapy water around the valve stem.
- Use mild liquid hand soap mixed approximately 80% water and 20% soap.
- Wait a minimum of five minutes and then visually inspect to see if bubbles are forming around the base of the valve stem.
- If you see bubbles, there may be an air leak.

**NOTE:** This bulletin does not cover repairs for air leaks. If you discover an air leak, repair as needed with usual warranty repair procedures.
